Flash flood in Brdy PLA in June 2024

PAVEL RICHTER

The article documents the course of the flash flood at the beginning of June 2024 in Brdy PLA, in the Příbram Region, including reflection on its causes and possibilities for limiting the consequences of this type of flood in the future. Publicly available information was evaluated from the hydrometeorological situation in the Archive of weekly reports on the CHMI website for the nearest station to the flood-affected area, namely Neumětely station. In that week, the highest weekly precipitation total for the Czech Republic was recorded at Neumětely station. When evaluating landscape development based on archival maps or orthophoto maps, changes with some negative effects on water retention in the landscape were observed. It was mainly the gradual expansion of urban development into the original mosaic of dry or wet meadows and small fields, straightening and piping of watercourses, ploughing their floodplains, land reclamation of spring areas, and their subsequent replacement with arable land.

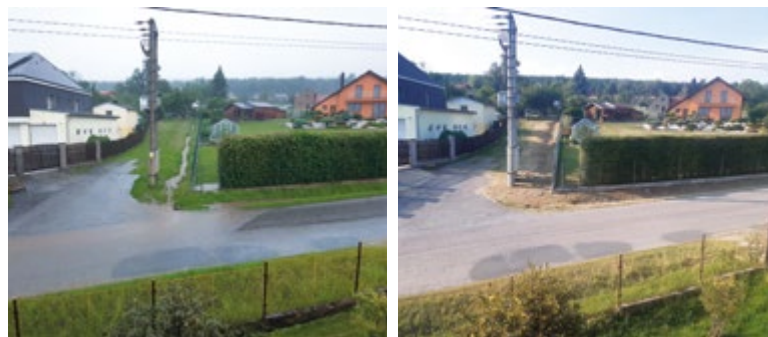
Fig. 3. Situation in the area of piping and canalization of a small stream below the main road in the village of Drahlín during the flash flood in June 2024 compared to standard situation at the end of August of the same year

of Drahlín and Sádek and their surroundings caused the basements of several houses in these villages to flood. Water poured from the forest, which is part of Brdy PLA, and also caused temporary impassability of some sections of roads, which complicated the work of firefighters in pumping water out of flooded basements [21]. The consequences of this flood were documented in the area of the piping and canalization of a small stream below the main road in the village of Drahlín, where the stream inundated. The sewerage system was not able to absorb such a large amount of water, causing it to overflow across the main road and subsequently flood the basements of several properties in the area. The situation as of 2 June 2024 compared to standard situation is shown in Figs. 3 to 6. In built-up areas, a very common issue in recent years has been undercapacity of riverbeds, undercapacity of bridges and culverts, clogged culverts that are not sufficiently managed, and undercapacity of watercourse piping (often all together). The above-mentioned situation only confirms this issue.

In built-up areas, it would be desirable to pay more attention to issues with under-capacity piping and culverts and clogged or under-capacity channels of small watercourses.

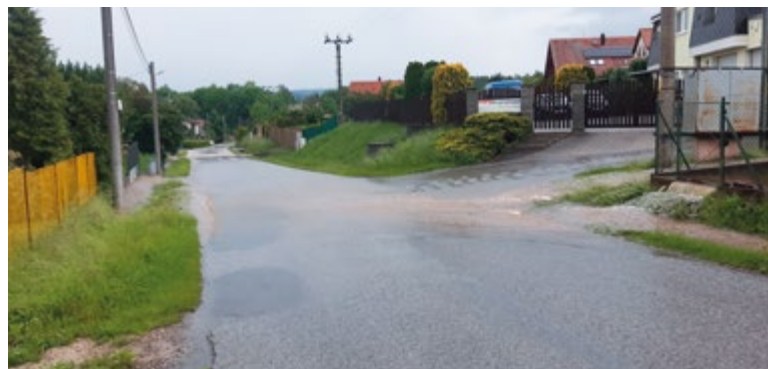
Fig. 4. Situation in Drahlín on the main road towards Obecnice in the area of piping and canalization of a small stream during the flash flood in June 2024

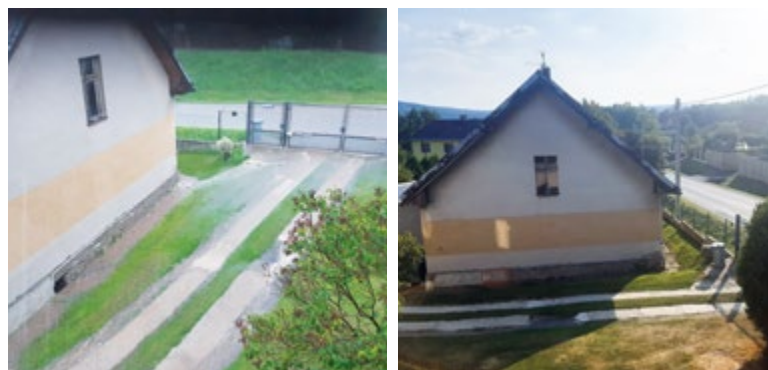
Fig. 5. Situation in Drahlín below the main road in locality No. 121 and 122 during the flash flood in June 2024 compared to standard situation at the end of August of the same year

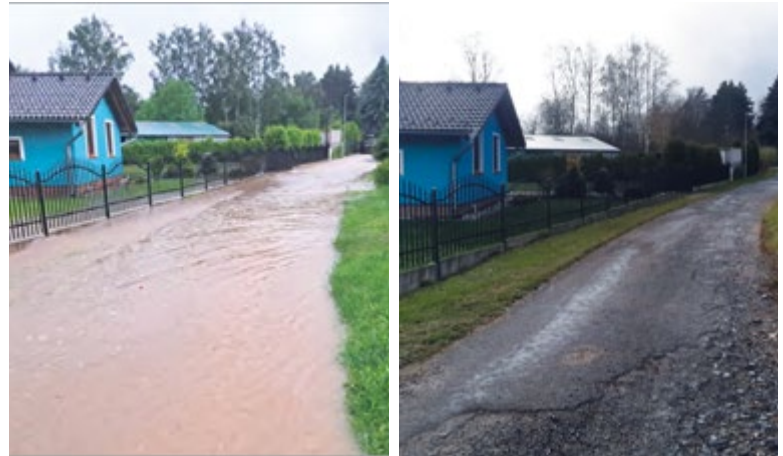
The pond in the eastern part of the village could not hold such a large amount of precipitation either. Drahlínský stream below this pond inundated and the adjacent local road was flooded (Fig. 7) [21]. The above-mentioned documented sites in the Drahlín cadastral area in the context of landscape development are shown in Fig. 8.

Fig. 7. Flooding of local roads in Drahlín in June 2024 (Drahlínský zpravodaj [21]) compared to standard situation in November of the same year

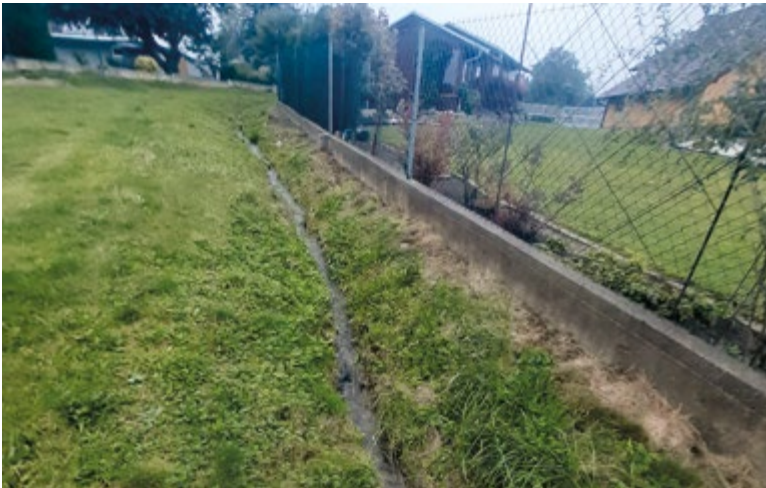
Fig. 6. Minor watercourse near the main road, standard situation (October 2024)

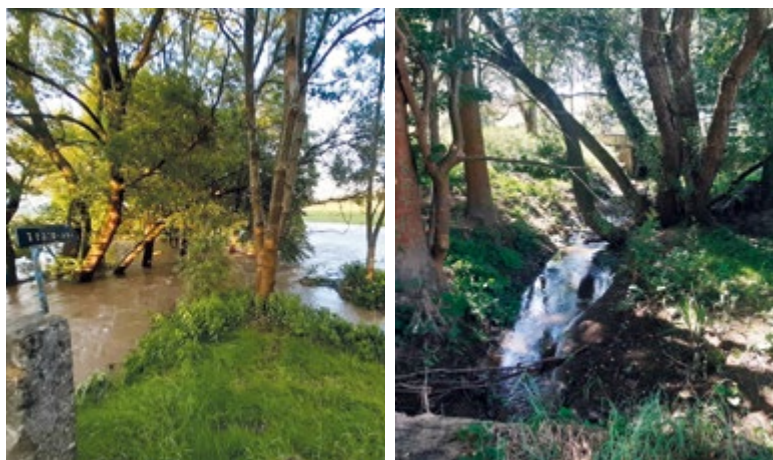
Drahlínský stream in the Sádek cadastral area also caused temporary traffic inaccessibility of the municipalities of Sádek and Drahlín towards Lhota u Příbramě and Příbram, as water overflowed the road bridge. The situation on 2 June 2024, after the peak had subsided, compared to the usual state, is shown in Figs. 9 and 10. The location in the context of landscape development is shown in Fig. 11.

Fig. 9. Situation near the road bridge over Drahlnický stream during the flash flood in June 2024, compared to standard situation at the end of August of the same year

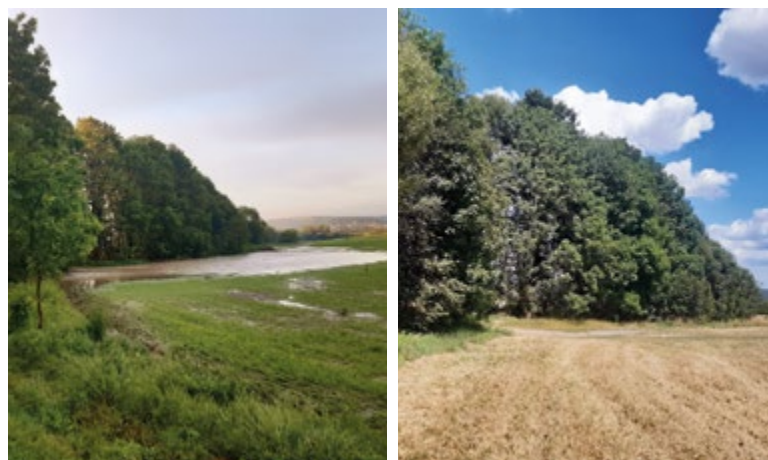
Fig. 10. Situation behind the road bridge over Drahlnický stream during the flash flood in June 2024, compared to standard situation at the end of August of the same year

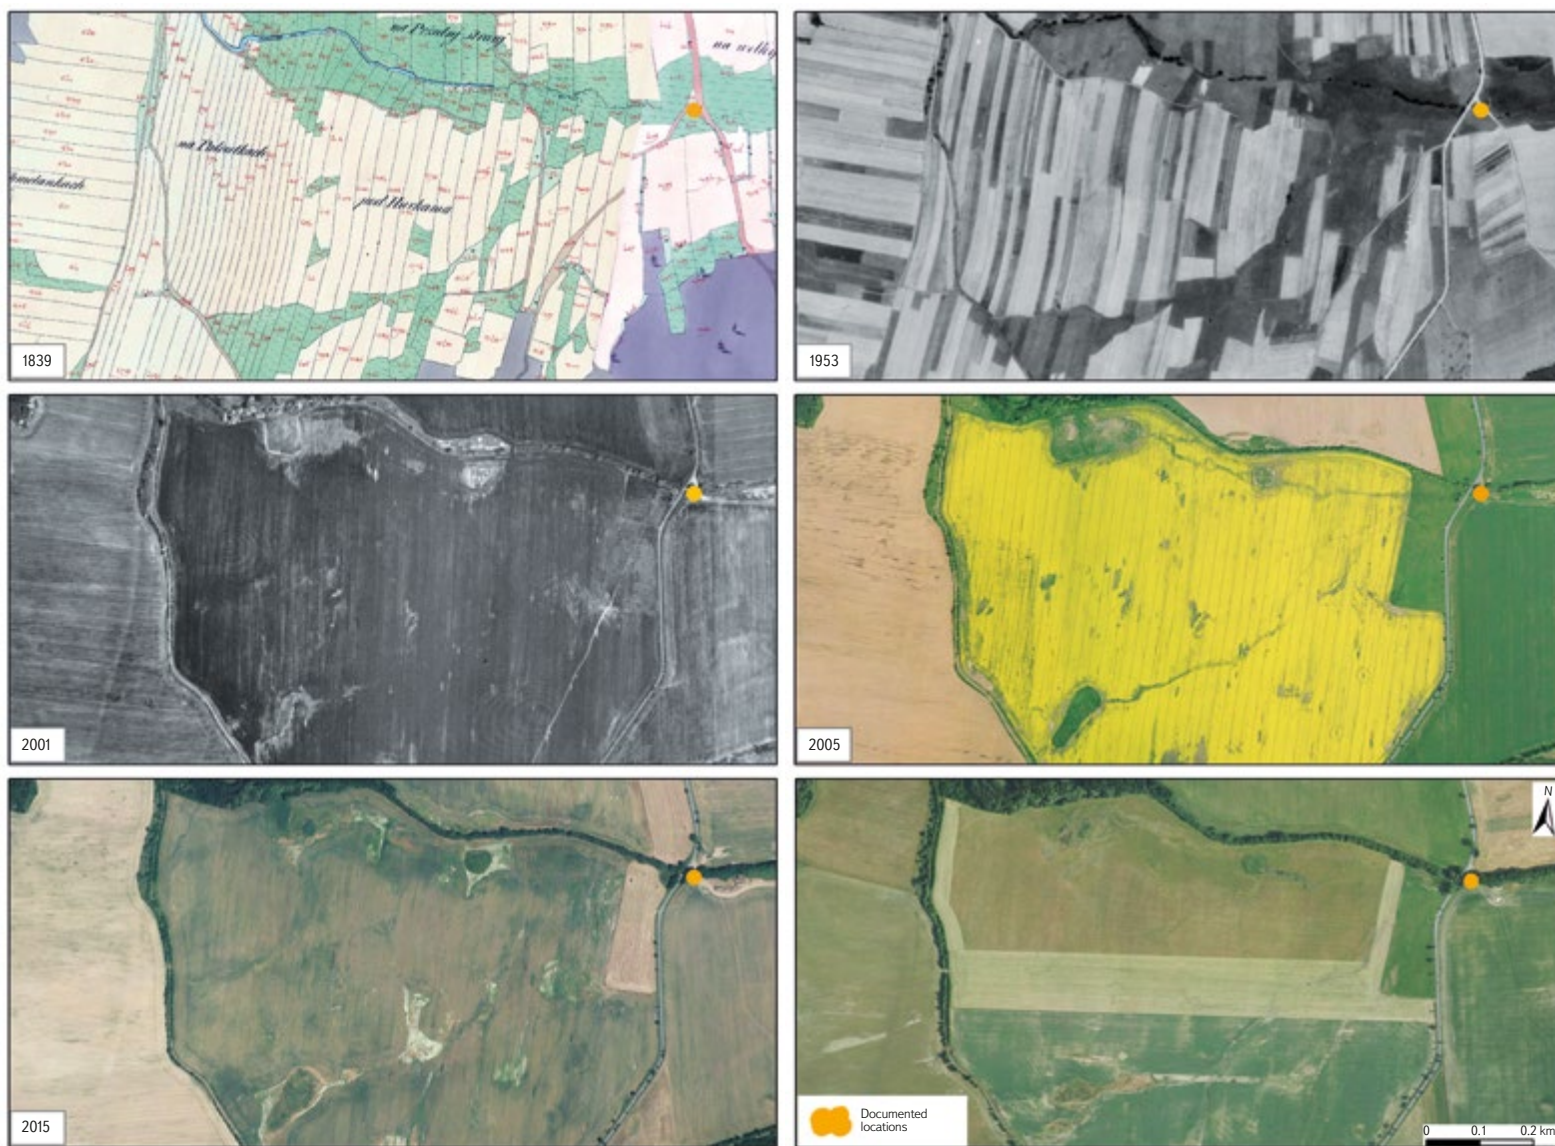
Fig. 11. Documented localities in Sádek cadastral area in the context of landscape development on the Stable Cadastre, Historical Orthophotomap from the 1950s, Archival Orthophotomaps from 2001, 2005 and 2015 and current Orthophotomaps of the Czech Republic

Given the location of this June flash flood in the headwaters of Drahlínský stream in the immediate vicinity of Brdy PLA, it can be clearly concluded that this landscape cannot accommodate such an amount of torrential rainfall, especially after previous rainfall. At first glance, this is a landscape that has been relatively little altered by human activity. However, a comparison of maps (Figs. 8, 11, and 13) shows that significant changes have occurred in this location, with a negative impact on the retention and purity of water in the landscape. This mainly involved the gradual expansion of a built-up area into the original mosaic of dry and wet meadows and small fields, as well as the reduction of the historical road network, the straightening and piping of watercourses and the ploughing of their floodplains. The land reclamation of spring areas and their replacement with arable land also had an impact; in some locations, after the destruction of land reclamation structures, the original landscape cover was partially restored with the help of succession (Fig. 11).

A comparison of the development of the location of watercourses and water bodies in the area shows that both the largest ponds in Drahlín cadastral area were founded only after 1953. In addition to the straightening – and in some sections even the piping – of the Drahlínský stream and its tributaries, the designation of the main stream also changed. On the current ZTM 10 and ZTM 50, the section that originates above Malý Drahlín, in the eastern part of the municipality of Drahlín, is designated as the main flow (Figs. 2 and 12). On the Maps of the Stable Cadastre, the current – partially piped – left-sided tributary of the Drahlínský stream, which rises in the northern part of the area in the current Brdy PLA and flows along the Drahlín village square, is drawn as the main stream. The current spring section is not drawn here (however, a group of mostly wet but also dry meadows is shown, indicating a possible small stream or spring area). On the Maps of the Stable Cadastre, the Drahlínský stream is listed under the name “Potuczek” (Figs. 8 and 11). At the borders of the cadastral areas Drahlín and Sádek, the usual watercourse outline only

passes into a small line and is then not drawn in the mosaic of wet meadows at all (Fig. 11). The Maps of Stable Cadastre are reliable; however, they have shortcomings in depicting small streams. In some locations where it is obvious that a small stream should be located (wet meadows are placed in the way that indicates a stream or a spring area), however, it is not there. Either it was a blanket spring area where no main stream existed, or some small streams were simply recorded only from a certain width [22, 23].

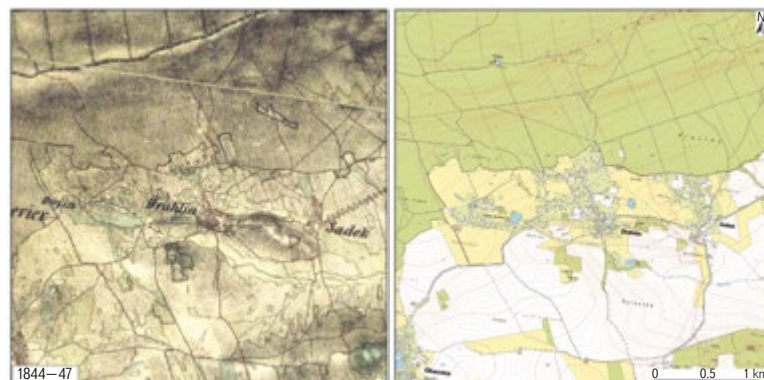
The forest stands were not able to contain these torrential rainfalls. Therefore, a field survey was carried out in this area as well. Since these forests were part of Brdy Military District until the end of 2015, there is a relatively dense network of paved roads and intensive forest management was also carried out here. A comparison of the area and condition of forest stands in the study area and its surroundings is shown on maps and orthophotomaps in Figs. 12 and 13, respectively. The current state of the forest, marked by the effects of erosion, is shown in Fig. 14.

Fig. 12. Comparison of the forest stands state, including the surrounding landscape, shown on Map of the 2nd Military Mapping and on current ZTM 10

Fig. 12 indicates that the area of forest stands has slightly expanded in the study area; however, the orthophotomaps in Fig. 13 clearly show that, due to intensive forest management, a large number of extensive clearings were created – this is most noticeable in the image from 2015. This was coincidentally the last year when this area was under the administration of the Military Forests and not under the Nature Conservation Agency of the Czech Republic (NCA CR).

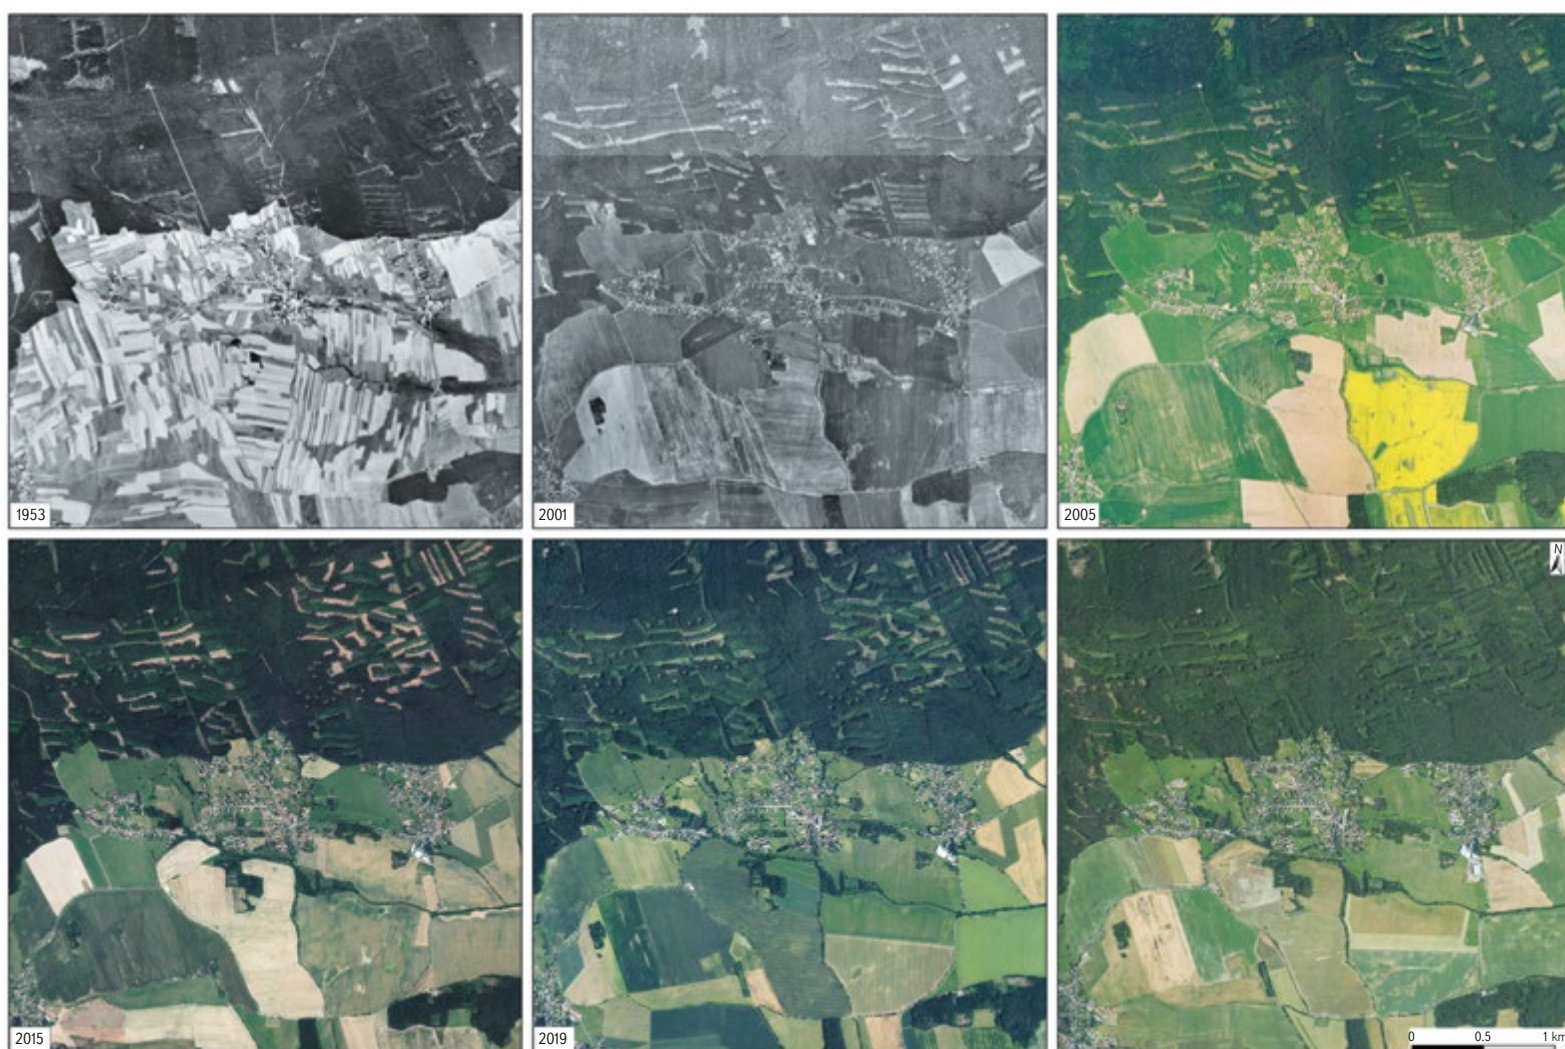
Fig. 13. Comparison of the forest stands state, including the surrounding landscape, shown on Historical Orthophotomap from the 1950s, Archival Orthophotomaps from 2001, 2005, 2015 and 2019 and current Orthophotomap of the Czech Republic

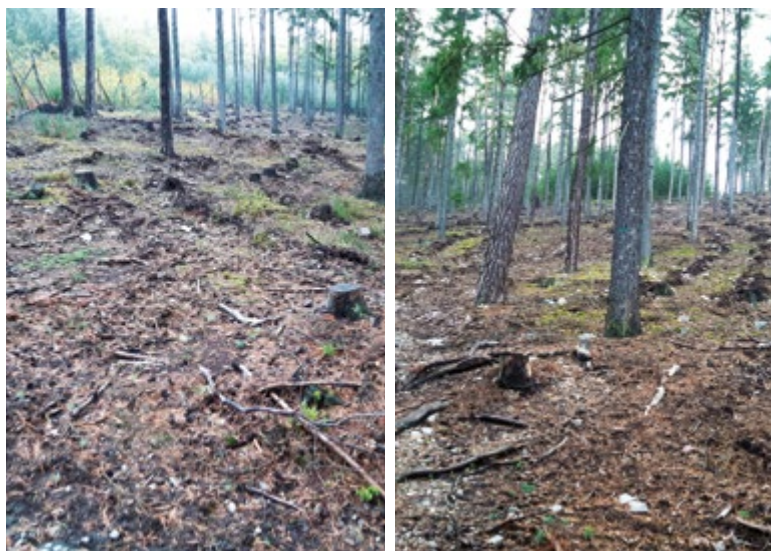
Fig. 14. The current state of the forest marked by the effects of erosion in Brdy PLA (October 2024)
