# The pond system on the Bečvárka river

## **PAVEL RICHTER**

## **ABSTRACT**

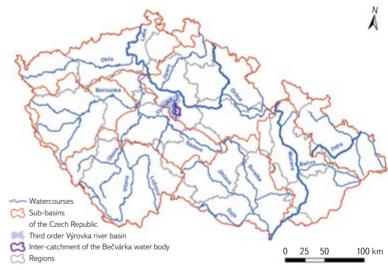
Fig. 1. The researched area in a hydrological and administrative context

of seven fourth order basins (HLGP) with a total area of 64.3 km² [1, 2]. From an administrative point of view, the water body is located in the Central Bohemian Region, partly in the districts of Kutná Hora (cadastral area Jindice and Solopysky) and Kolín (cadastral area Bečváry, Bošice u Kouřimi, Červený Hrádek u Bečvár, Horní Chvatliny, Mlékovice, Poďousy, Přebozy, Svojšice u Kouřimi, Zásmuky, and Žabonosy). Its catchment area covers seven cadastral areas in the Kutná Hora district and 24 cadastral areas in the Kolín district (*Fig. 1*). From the perspective of drought in the landscape, all cadastral areas in the catchment area are among those at risk of drought, with the exception of cadastral areas in the source areas of the Bečvárka and Miletínský stream (*Fig. 2*) [1].

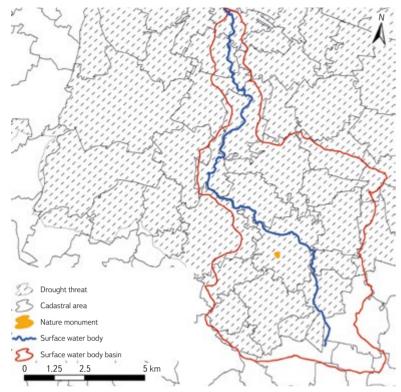
Fig. 2. The Bečvárka water body basin from the perspective of drought issues in the context of nature protection

There is only one natural monument in the described area (*Fig. 2*), namely Lůmek u Bečvár, which was declared on 12 December 1986 covering an area of 0.2499 ha with a legal protection zone of 2.1198 ha. The reason for the declaration was the occurrence of the rare griquaite rock and the rich deposit of Upper Cretaceous fossils [10].

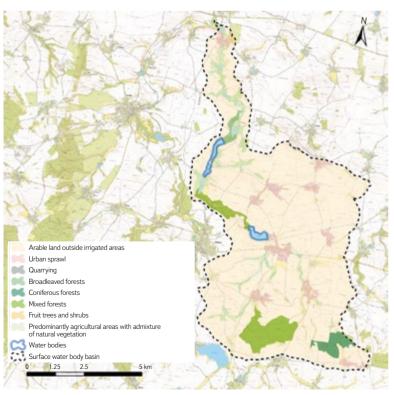
Fig. 3. CORINE Land Cover 2018 in the Bečvárka water body basin in the context of BTM 10  $\,$

According to the CLC, which is largely generalized [8], the arable land class excluding irrigated areas prevails, covering 80.38 % of the basin. The following classes are: predominantly agricultural areas with an admixture of natural vegetation, mixed forests, and urban discontinuous development, each covering over 5 % of the basin area. Other classes occupy a very small part of the area. Water bodies make up 0.88 % of the basin and due to the generalization of this type of cover, with only two sites classified as water bodies. One is Mlýnský pond, near Bečváry, and the other is formed by the ponds of Utopenec and Stojespal, near Mlékovice (Fig. 3, Tab. 3).

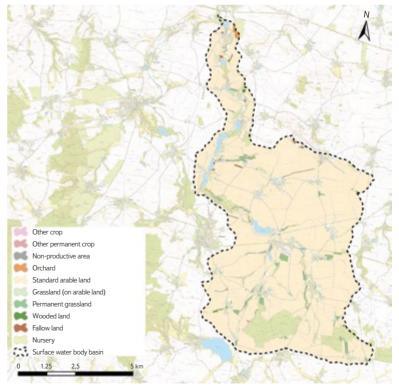
Fig. 4. Land use according to LPIS 2023 in the Bečvárka water body basin in the context of BTM 10

The LPIS records only agriculturally used areas for which economic agriculturalist entities receive subsidies [9]. It means that the entire area of the river basin is not covered by the LPIS, it is only 4,960.2 ha, which represents 77.14 % of the area. In the LPIS, the dominant land use is standard arable land (97.15 %), around 2 % is covered by permanent grassland, while the remaining land use types in the LPIS are negligible (*Fig. 4, Tab. 4*).

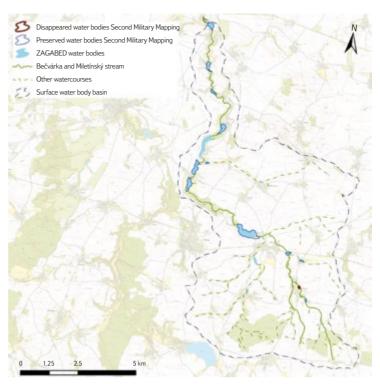
Fig. 5. Development of the pond system in the Bečvárka water body basin from the 2nd Military Mapping to the present in the context of BTM 10

the upper reaches of the Bečvárka, while Utopenec pond is on the middle Bečvárka near Mlékovice, after Stojespal (*Figs. 5* and *7*). In terms of area, it ranks second only to the largest pond in the basin – Mlýnský pond near Bečváry. Medium-sized ponds include Bosňák on the Drahobudický stream (*Fig. 10*). The smallest new ponds are in Drahobudice and Dolní Chvatliny. The total area of the current ponds is approximately 11 ha larger than the area of the historical ponds, even though almost all individual historical ponds had an area larger than now (*Fig. 5, Tab. 5*). From the map comparison, it is clear that this reduction in the area of individual ponds is caused by the overgrowing of the littoral zone of the given historical pond. This can be clearly observed in particular at the ponds of Mlýnský, Rybník, and Stojespal (*Figs. 7, 10*, and *11*). The current state of the ponds of Stojespal, Utopenec, Rybník, Rozkoš, Mlýnský, and Bosňák is shown in *Figs. 12–17*.

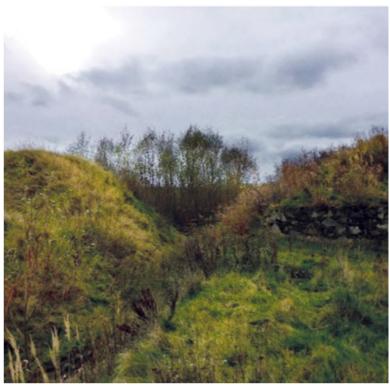
Fig. 6. The gap in Mlékovický Pond dam and the state of vegetation in the flooded area four years after the breach, as of 2017 [20]

In this context, it can be considered that Mlékovický pond would not have to be restored and would become the subject of some form of protection within nature conservation associated with the appropriate management of this site. After twelve years of succession, this area is certainly more significant in terms of water retention in the landscape than as a pond used in the usual way for fish production today. Moreover, the restoration of the pond would be financially very demanding, given its current state. However, the owner of the pond is a large regional fishing company that manages a significant part of the ponds in the area. Such a solution, respecting the current state, would therefore probably also represent a large financial burden associated with the necessary change of owner.

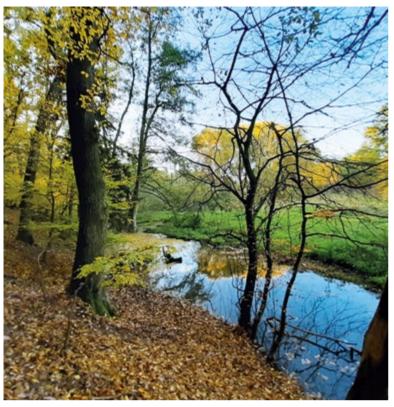
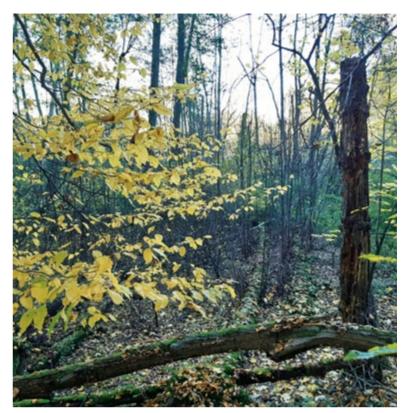
Fig. 9. The current state of Mlékovický pond (October 2024)

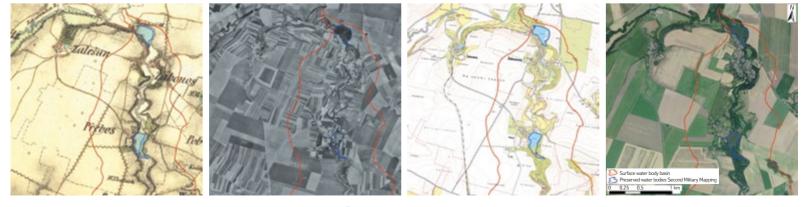
Fig. 11. Comparison of pond system development on the Bečvárka river near Žabonosy village, including the surrounding landscape, shown on a map of the 2nd Military Mapping, on a Historical Orthophoto map from the 1950s, on the current BTM 10, and on the current Orthophotomap of the Czech Republic

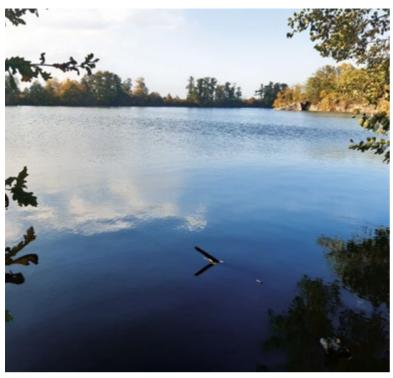
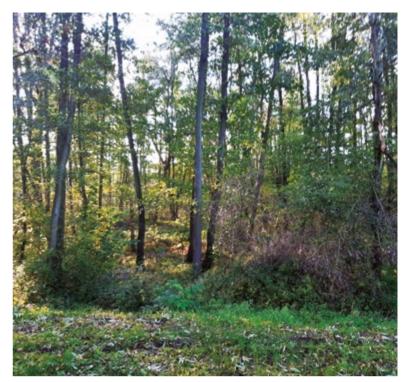
Fig. 12. The current state of Stojespal pond, including a disappeared historical part (October 2024)

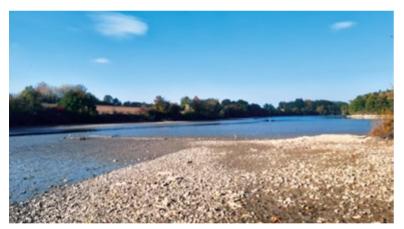
Fig. 13. The current state of Utopenec pond (October 2024)

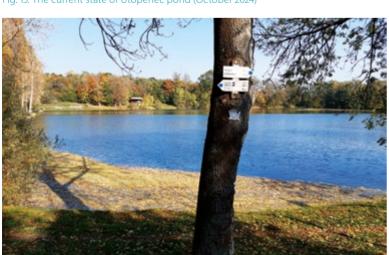
Fig. 15. The current state of Rozkoš pond (October 2024)
